Hovnanian Homes - Est at Huntington Valley  
1st Inspection

**Inspection Guide**

Name of Inspected Site: <u>Estates at Huntington Valley</u>		Date & Time: <u>9:35am/11:45am</u> <u>3/19/03</u>	
Local ID # or Drawing #: <u>Boucher &amp; James Job# 99284</u>		Acreage: <u>~47</u>	Phase: <u>II</u> <u>Buildi</u>
NPDES Permit #: <u>PAR10T 682</u>			
SIC: <u>1521</u>	Type of Construction ( <u>residential</u> commercial, industrial, agricultural, silvicultural, municipal):		
Commencement Date:	Address: <u>Pine Rd</u>		
City: <u>Lower Merion</u>	County: <u>Mont</u>	State: <u>PA</u>	Zip:
Lat & Lon: <u>40°01.965' N - 75°02.451' W</u>			
EJ Information: <u>None</u>			
Name of Owner:		Phone:	
Name of Contact:			
Address:			
City:	County:	State:	Zip:
Name of Developer: <u>Hannan &amp; Thomas</u>		Phone: <u>(215) 493-4230</u>	
Name of Contact: <u>Mike McLeary</u>			
Address: <u>301 Oxford Valley Rd Suite 150B</u>			
City: <u>Yardley</u>	County: <u>Bucks</u>	State: <u>PA</u>	Zip: <u>19067</u>
Name of Contractor:		Phone:

(NPDES construction Activity)  
2nd Inspection 2/23/04

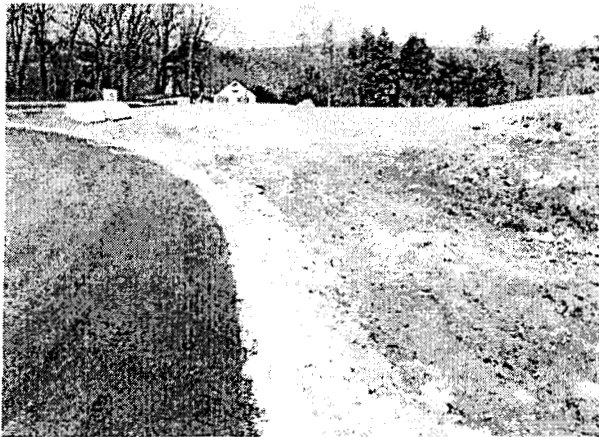
Photo -2  
View of the street on the west side of Basin #1. Approximate location identified as - A.1 on the attached map.

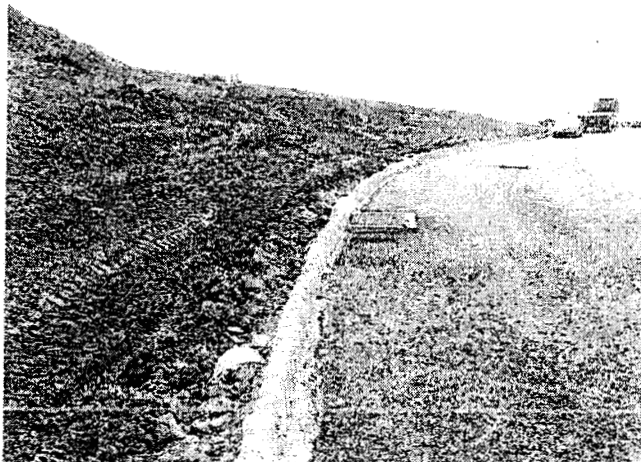
Photo -3  
View of the street on the west side of Basin #1. Approximate location identified as A.2 on the attached map.

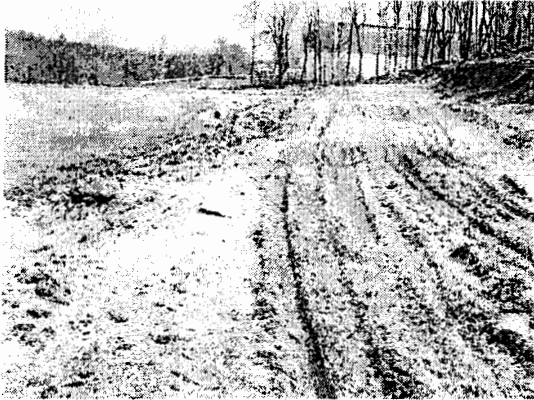
Photo -4  
View of a path for heavy equipment along south side of Basin #1. View facing east.  
Approximate location identified as B.1 on the attached map.

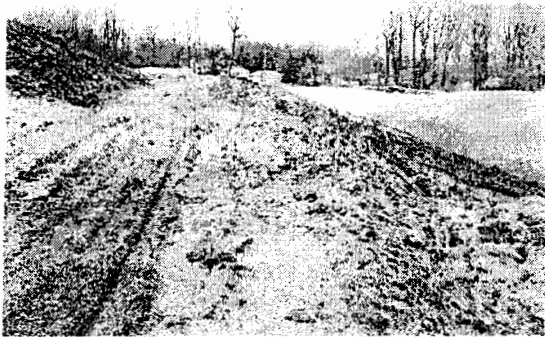
Photo -5  
View of a path for heavy equipment along south side of Basin #1. View facing west.  
Approximate location identified as B.2 on the attached map.

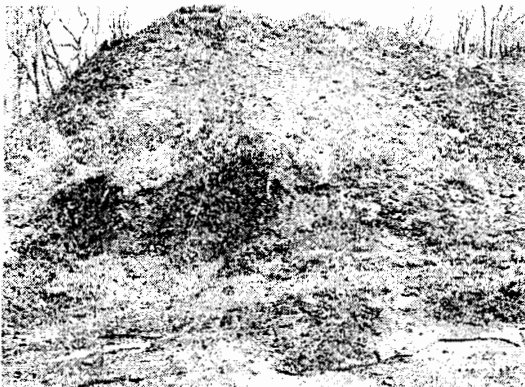
Photo -6  
View of a Stockpile near Basin #1  
Approximate location identified as B.3 on the attached map.

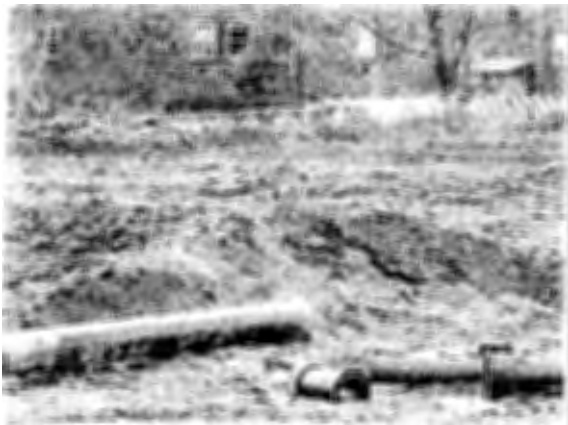
Photo -14  
View of Interior of Site - Southern  
Approximate location identified as D.4 on the  
attached map.

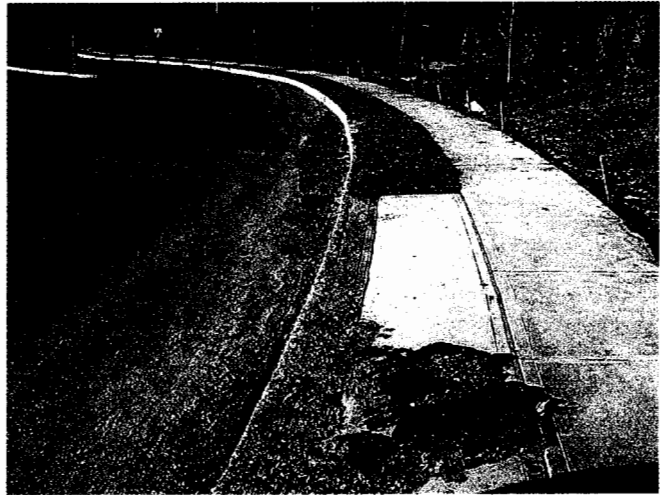
Photo #1 is a view of street, sidewalk and silt fence at the main entrance to the Site. The silt fence at the bottom of the slope on the right side of this photo is identified in Photo #2. This area is labeled "A" on the attached map.

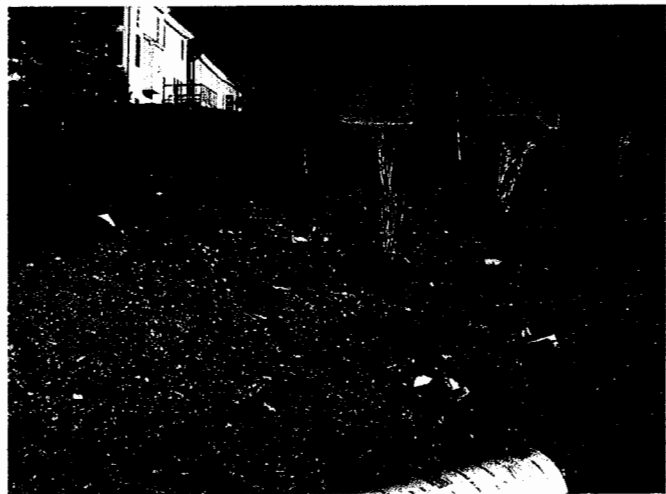
Photo #2 is a view of ground cover on the slope on the right side of Photo #1. This area is labeled "A" on the attached map.

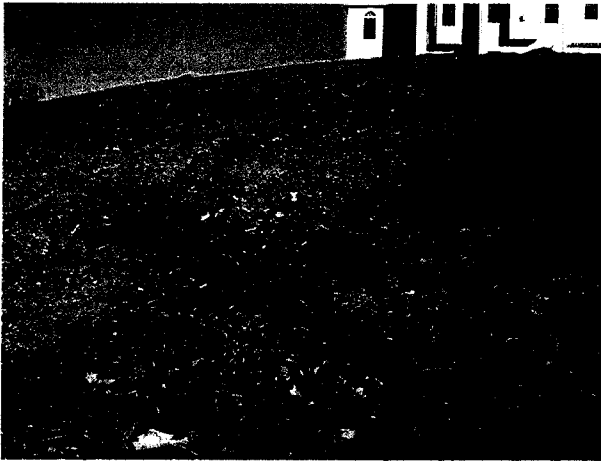
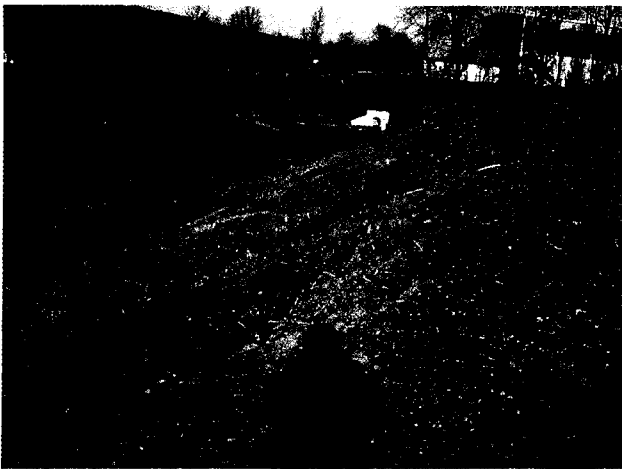
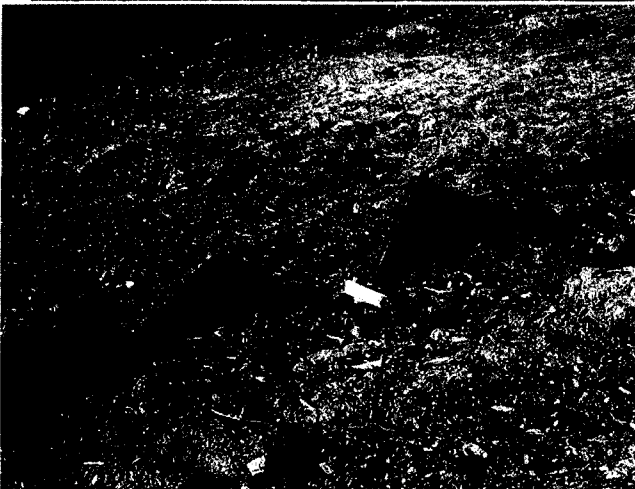
Photos #3 - #7 are views of a slope leading to Basin #1 at the Site. This area is labeled "B.1" on the attached map.

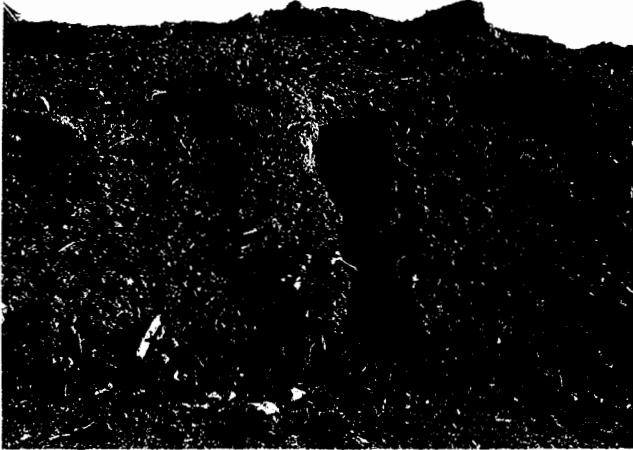
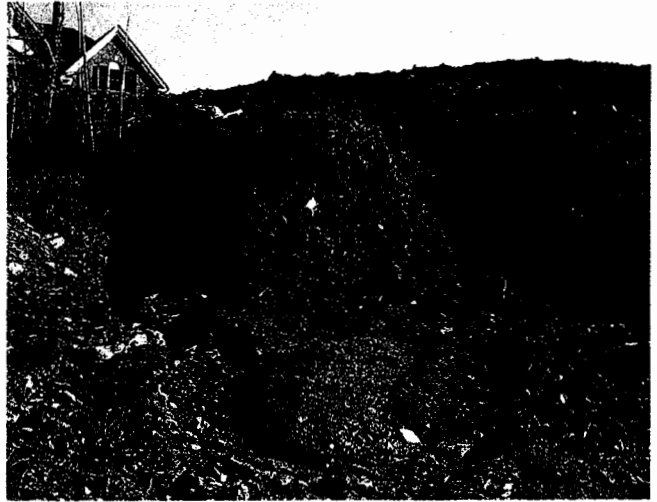
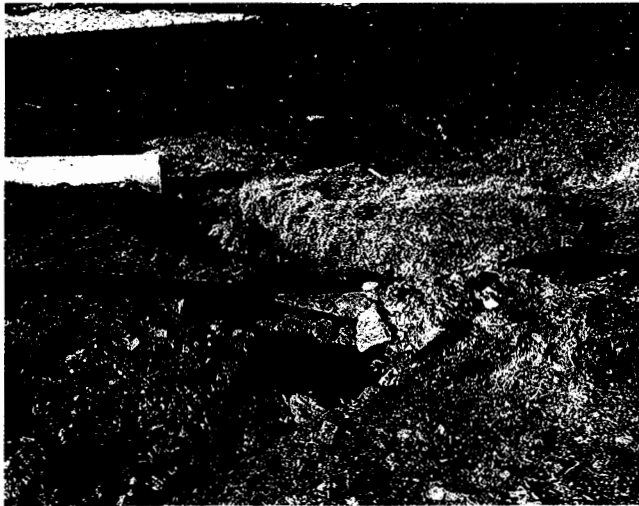
Photos #11 - #14 are views of a slope leading to Basin #1 at the Site. This area is labeled "B.3" on the attached map.

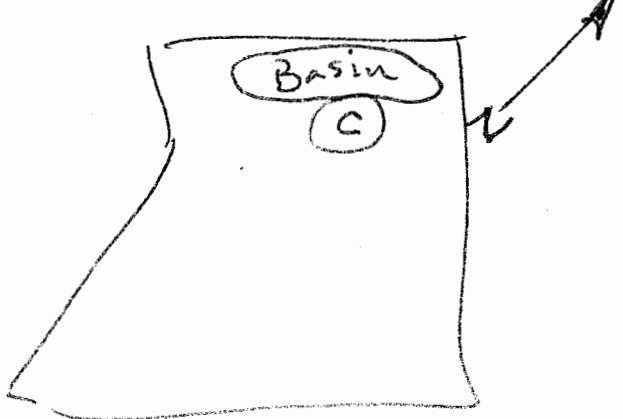
Perimeter location on site outline:

Location <u>C</u>	Photo # <u>15-17</u>	Location	Photo #
Location	Photo #	Location	Photo #
Location	Photo #	Location	Photo #
Location	Photo #	Location	Photo #
Location	Photo #	Location	Photo #
Location	Photo #	Location	Photo #
Location	Photo #	Location	Photo #

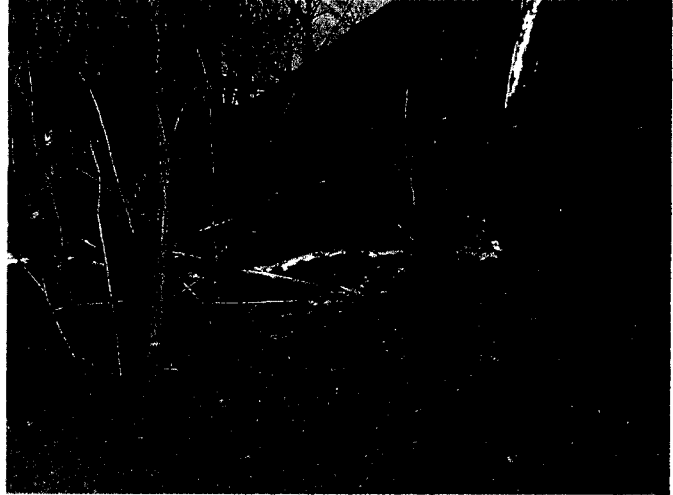
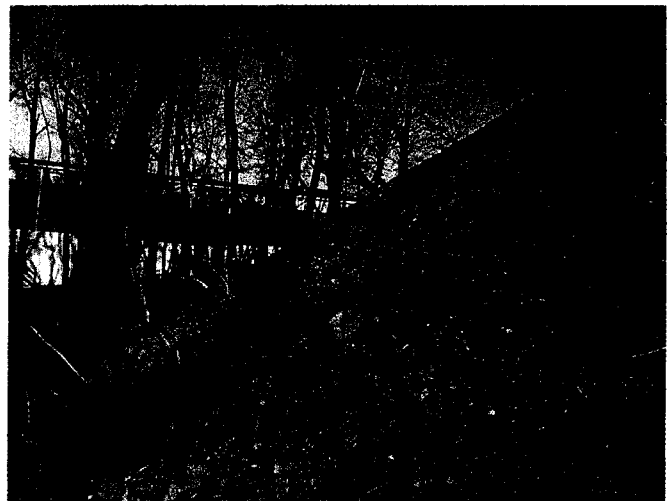
Photos #15 - #17 are views of a tree protection area near Basin #1 at the Site. This area is labeled "C" on the attached map.

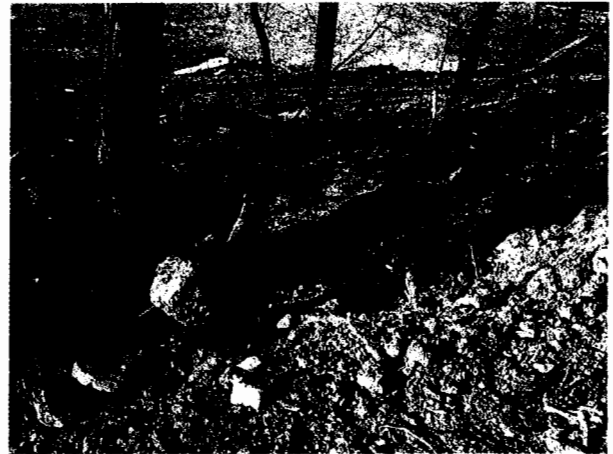
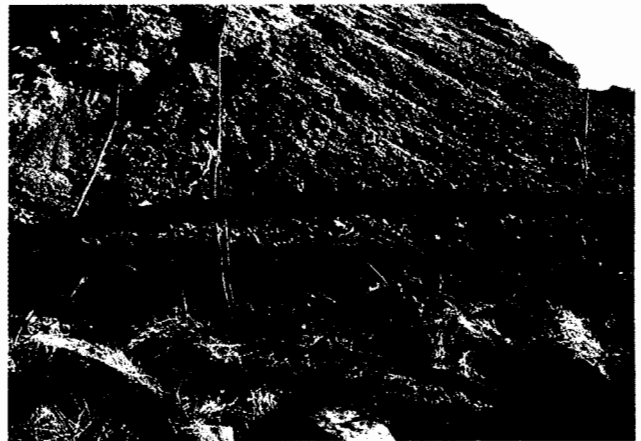
Photos #18 - #21 are views of a soil stockpile near Basin #1 at the Site. This area is labeled "D" on the attached map. NOTE: [Photo #18 and Photo #15 are the same.]

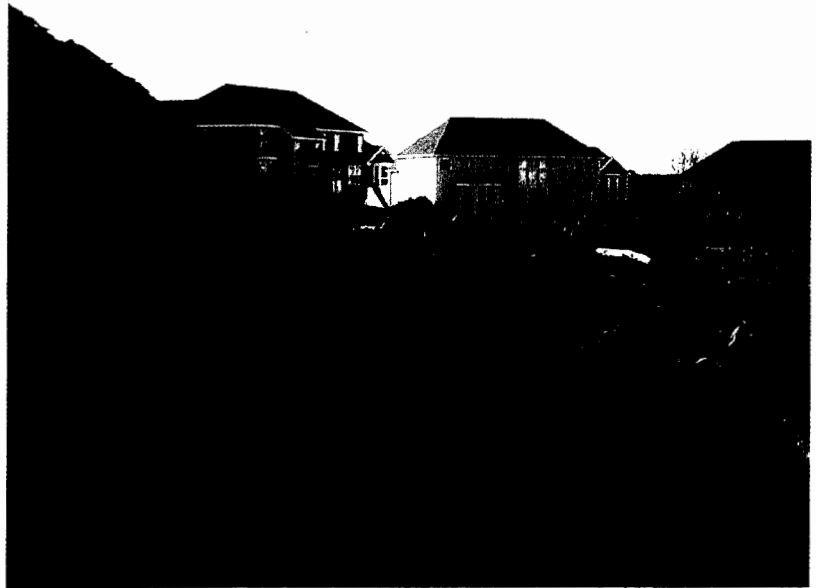
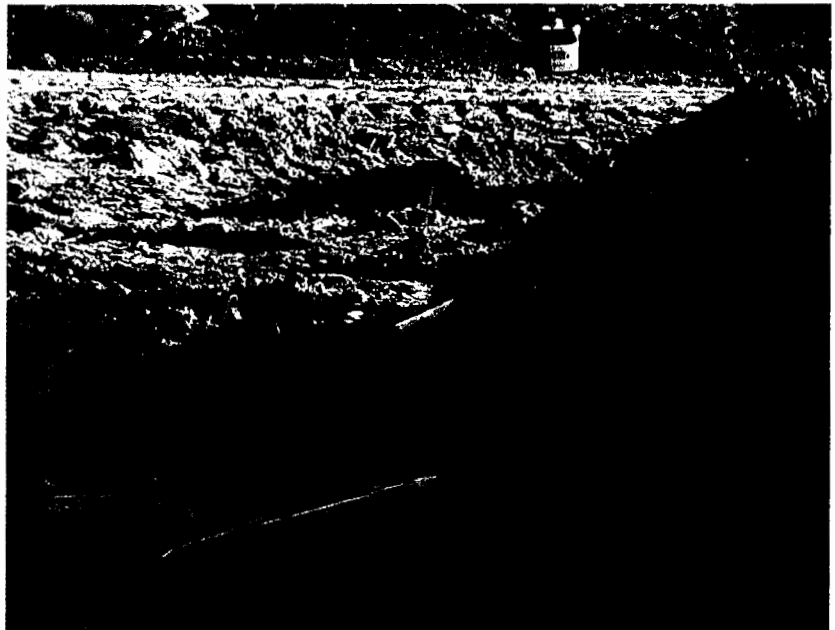
Photos #22 - #23 are views of a soil stockpile at the Site,. This area is approximately located near House #58 and labeled "E" on the attached map.

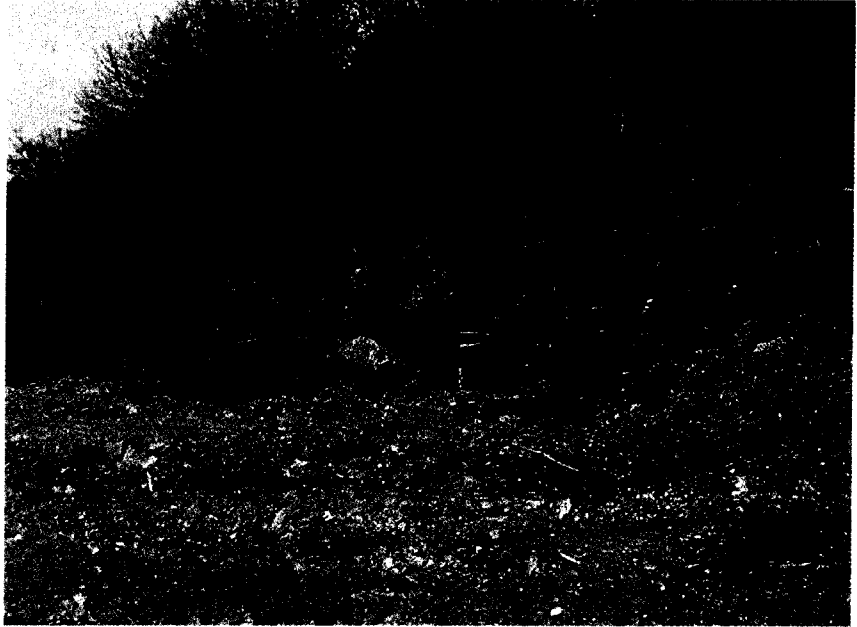
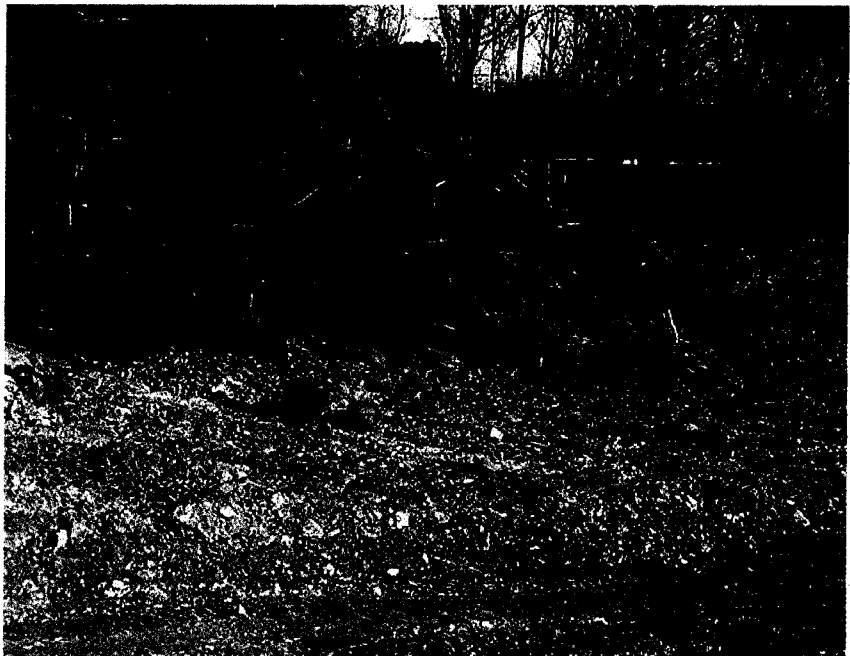
Photos #22 - #23 are views of a soil stockpile at the Site,. This area is approximately located near House #85 and labeled "F" on the attached map.

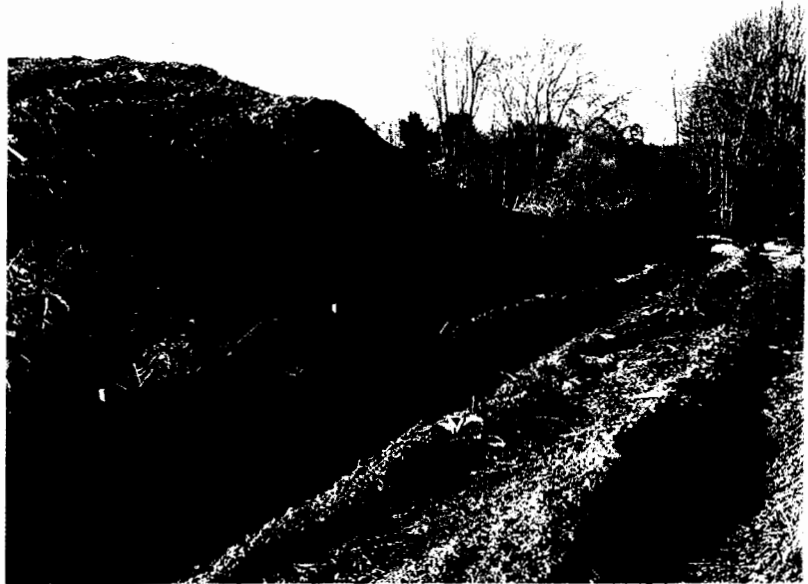
Photos #27 and #28 are views of a soil stockpile at the Site.. This area is approximately near House #91 and labeled "H" on the attached map.

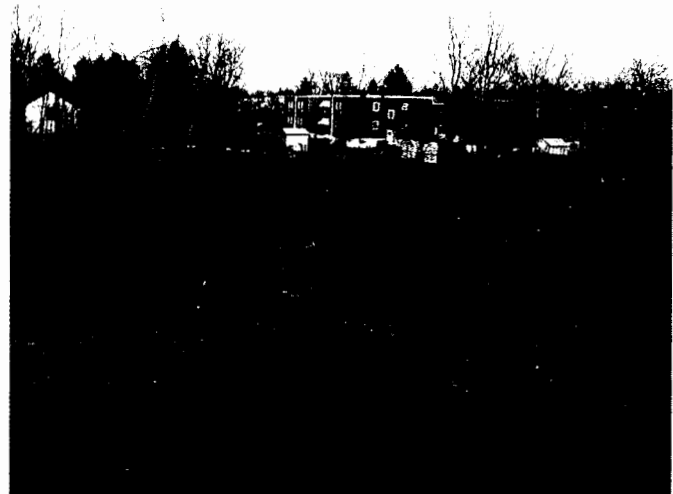
Photo #30 -

Overall view of the location of Sediment Basin #2, identified as "I.b" on the attached map..

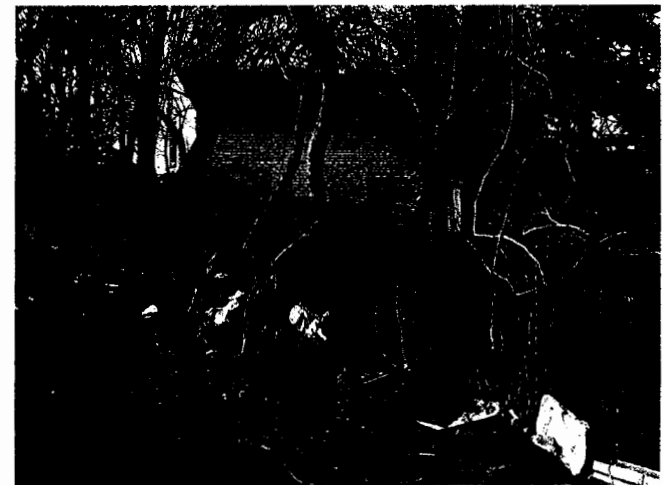
Photo #31 -

Approximate location is the northeastern edge of the Sediment Basin #2., identified as "I.c" on the attached map.

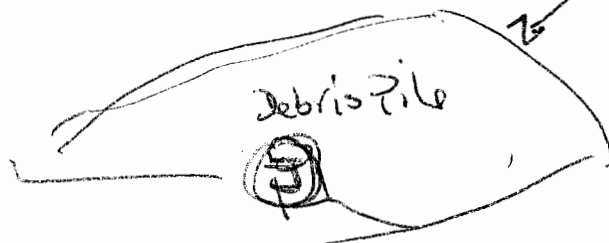
Local sketch of observation:

This location will be referred to a "J"

Photos #32 and #33 are views of the edge of a debris pile at the Site,. This area is labeled "J", near the location of House #60 on the attached map.

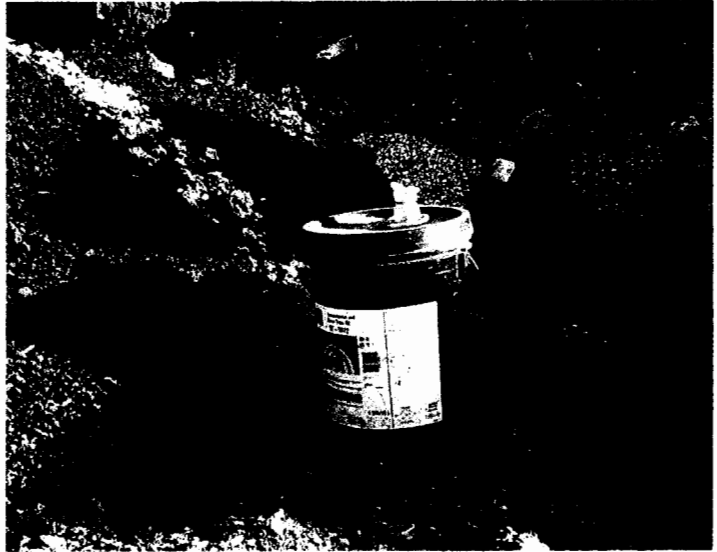
Photo #32 -

View of a bucket with the title:  
"Transmission and Drive Train Oil" at  
the debris pile, in the area labeled "J",  
near House #60.

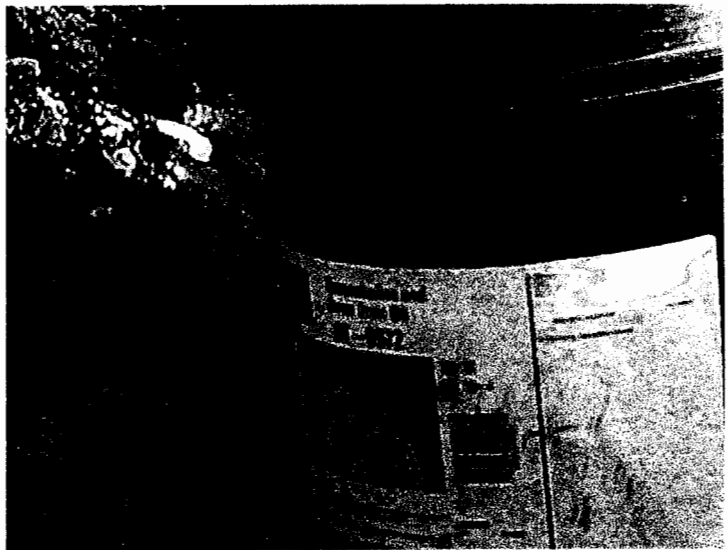
Photo #33 -

Close-up view of the bucket with the  
title: "Transmission and Drive Train Oil"  
at the debris pile, in the area labeled "J",  
near House # 60.
